An Audit of Small Culvert Installations in Nova Scotia: Habitat Loss and Habitat Fragmentation

Darria A. Langill and Phil J. Zamora

Canadian Technical Report of Fisheries and Aquatic Sciences No. 2422

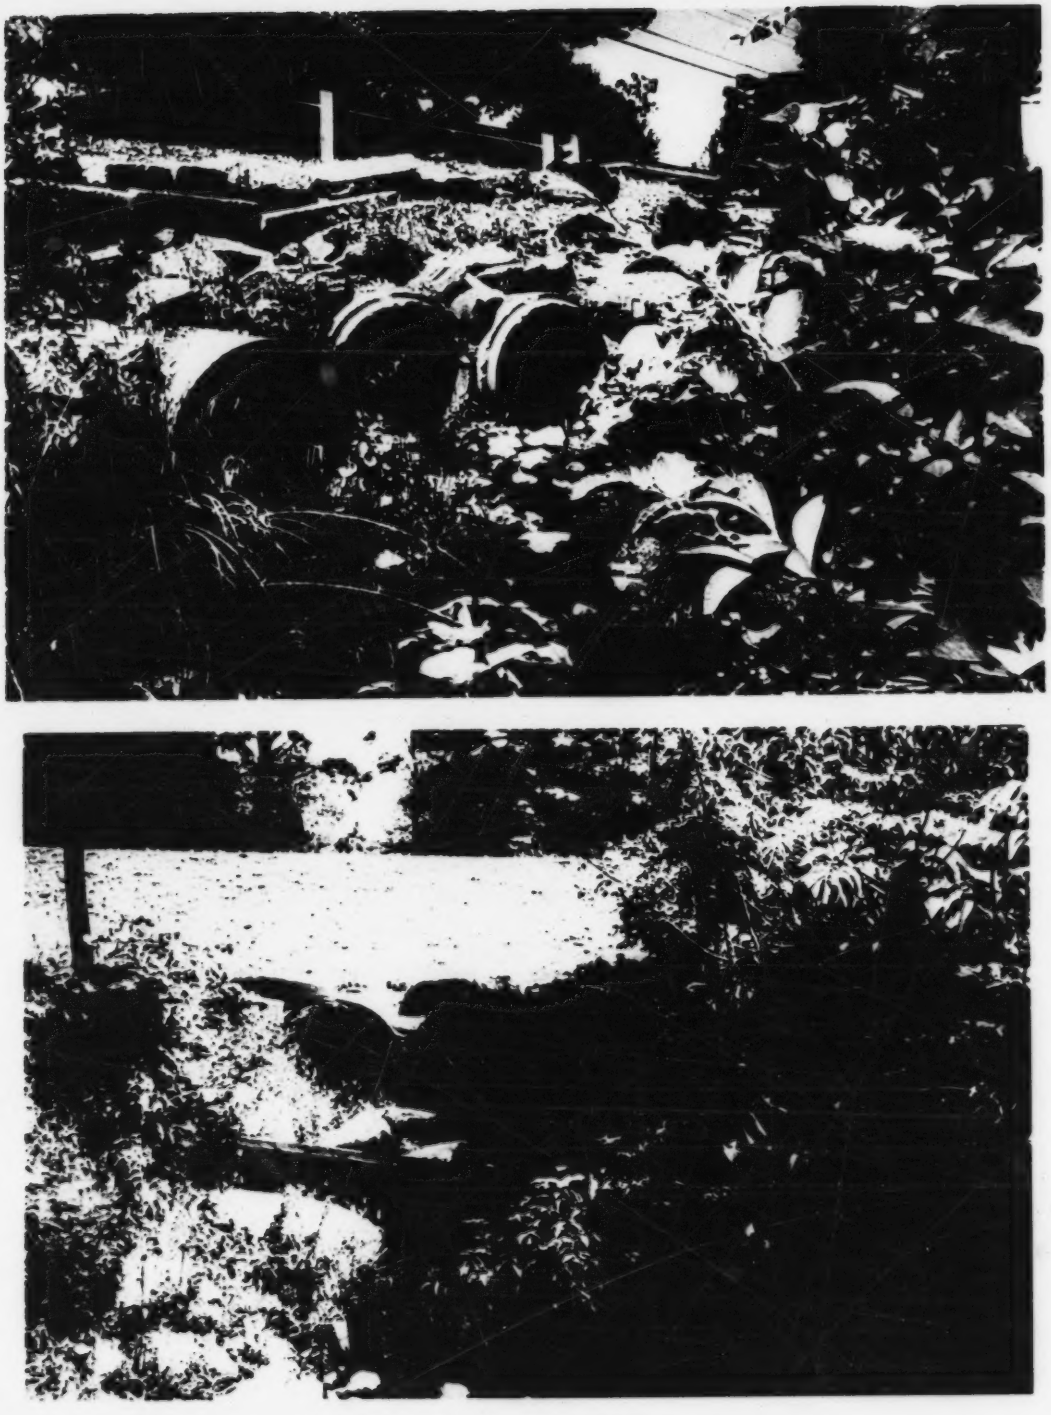
Figure 10: Culverts not installed as indicated in original notifications.
